VILLAGE OF RYLEY

INFRASTRUCTURE ASSESSMENT AND TEN-YEAR CAPITAL PLAN

Date: March 23, 2018

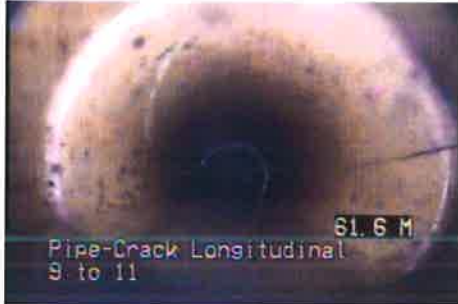
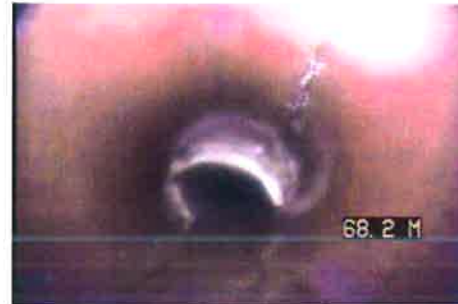
- ▶ 54 Avenue between MH 34 and MH 35 @ 61.6 m and 68.2 m

Within the Village collection system, there were a number of locations where the VCT pipe had cracked, broken, sagged, or was physically deformed due to fracturing. These assorted pipe defects have been classified as critical deficiencies, and the sections of pipe that exhibited these defects during the CCTV

HIGH-PRIORITY PIPE LOCATIONS – CRITICAL DEFICIENCIES

inspections are highlighted as “high priority” in **Table 2.6**. Approximately 44% (see **Tables 2.6** and **2.7**) of the pipe segments inspected were found to be deficient, with only 10% being considered high priority. The segments of pipe indicated in **Table 2.6** will need to be replaced in order to restore desired flow rates.

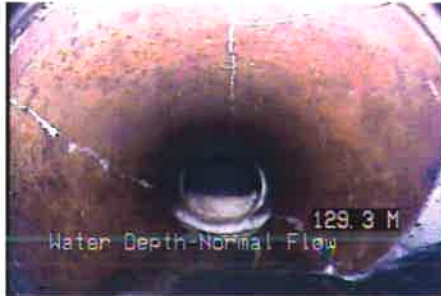
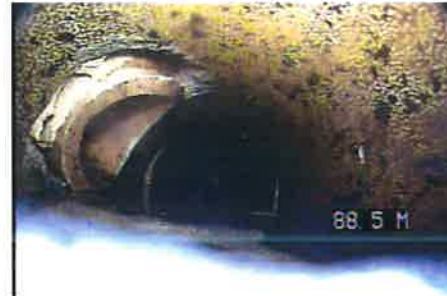
- 55 Avenue between MHx 39 and MH 39 @ 129.3 m and 88.5 m

Other key pipe locations identified in the CCTV inspections are outlined in **Table 2.7**. These sections of pipe are classified as “moderate priority” based on the potential for the pipe to be salvaged. These sections of pipe displayed deficiencies during the CCTV inspections, such as cracking and encrustations, which are potentially repairable with a Cured-in-Place-Pipe (CIPP) product. As discussed in Section 2.4.6.1, CIPP may be a cost-effective solution for these locations where the pipe has not suffered serious deformation.

MEDIUM-PRIORITY PIPE LOCATIONS – MODERATE DEFICIENCIES

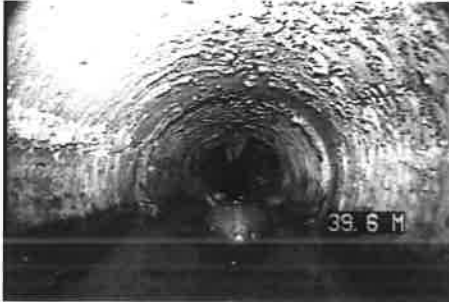
- ▶ 55 Avenue between MH 38 and MH 39

SECTIONS OF PIPE WITH IMPASSABLE ENCRUSTATIONS

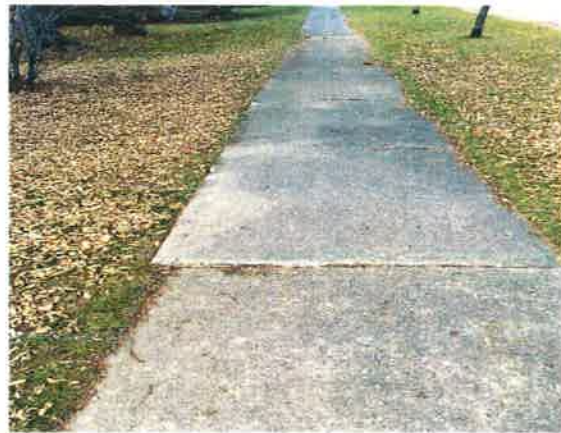
Faulting: Segment/Asset_Id 61643S

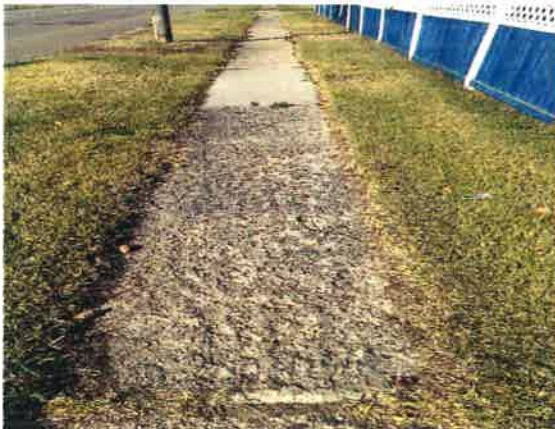
Scaling: Segment/Asset_Id 123243N

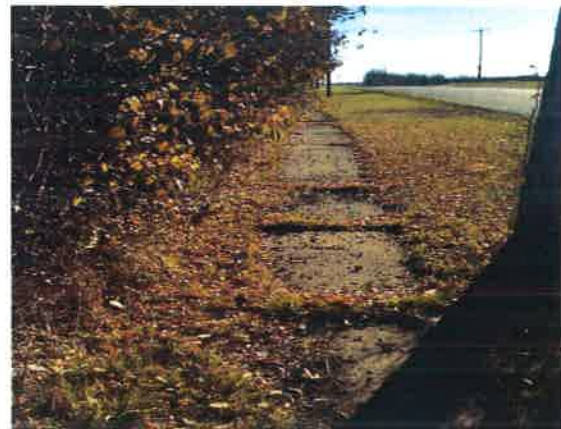
Obstruction: Segment/Asset_Id 332613N

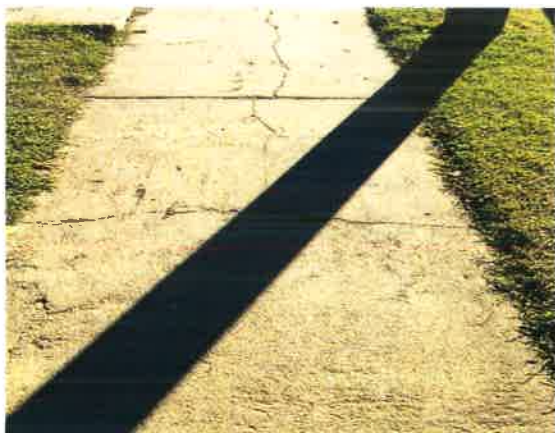
Shattered Slab: Segment/Asset_Id 343246N

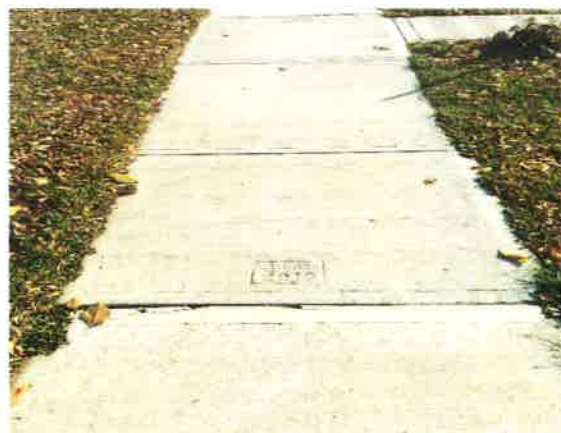
Spalling: Segment/Asset_Id 71135S

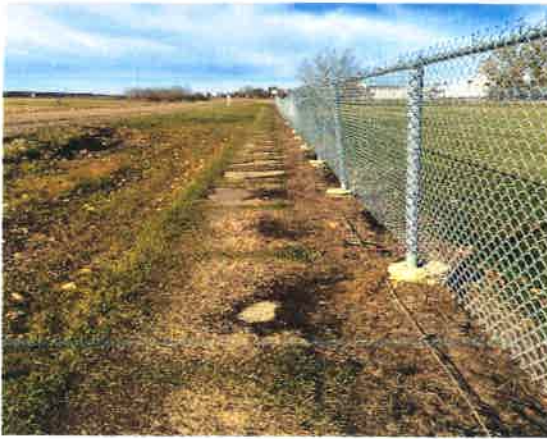
Trip Hazard: Segment/Asset_Id 153464N

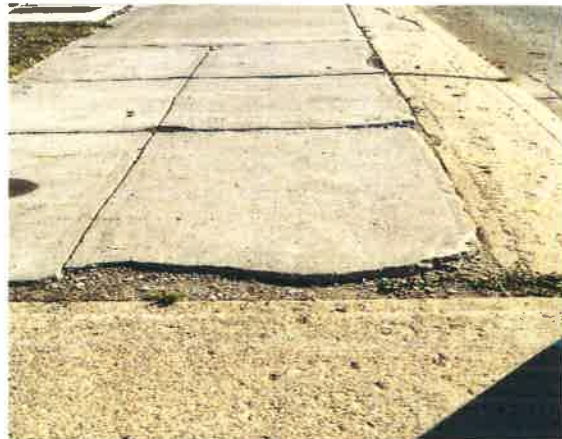
Trip Hazard: Segment/Asset_Id 75510N

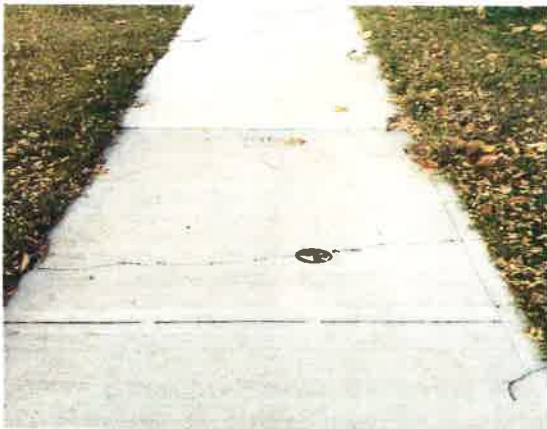
Linear Cracking: Segment/Asset_Id 165619N

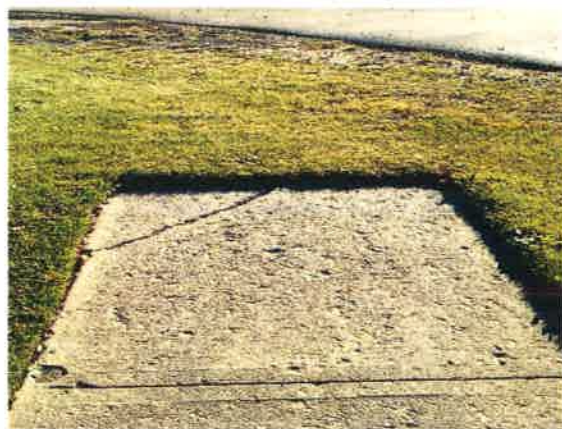
Corner Break: Segment/Asset_Id 332613N

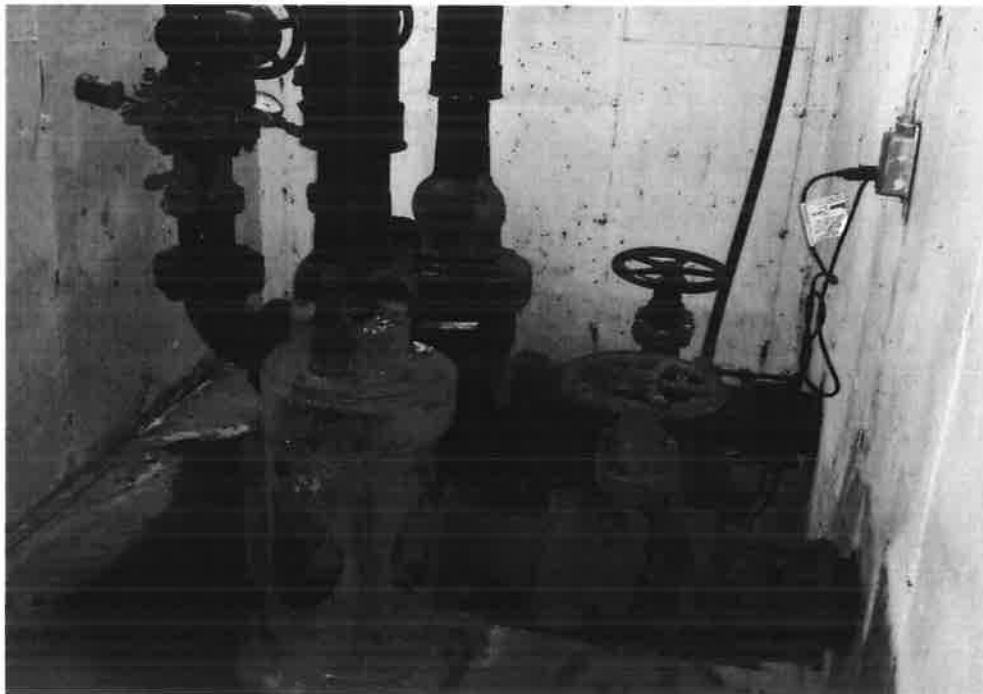
Figure 1: Existing Wastewater Pumps

The Lift Station contains two vertical frame mounted solids handling pumps sitting at the bottom of the dry well and connected by a long coupled shaft to motors located on the main floor slab. Each pump is rated for 15.14 L/s (240 USgpm) flow and 12.2 m (40 ft.) of total dynamic head (TDH). However, after 38 years of operation and the poor state they are in, these pump's performance is expected to be significantly reduced due to wear and tear. In addition, the wastewater pumps have outlived their useful service life and should be replaced. Below is a Figure 1 showing the current state of the pumps.

In addition, all the piping and valving components of the pumping system in the dry well are severely corroded and exhibit difficulty in operation. The corrosion is attributed to poor ventilation and age of the system.
