VILLAGE OF RYLEY

INFRASTRUCTURE ASSESSMENT AND TEN-YEAR CAPITAL PLAN

Date: March 23, 2018

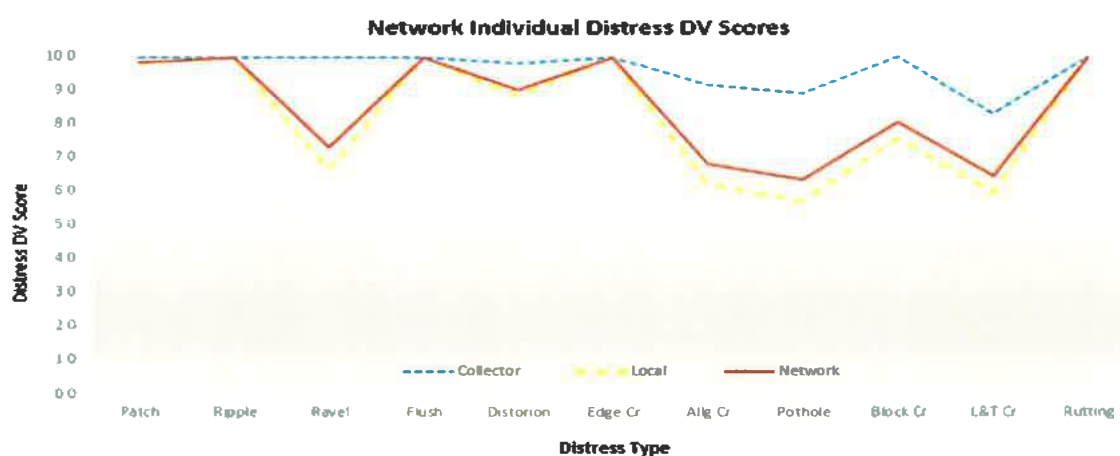
Figure 3.3: Network Individual Distress Comparison

Figure 3.3 shows the network average individual distress scores by functional class and the entire network. The lower scoring distresses are the most prevalent in the pavement network.

NETWORK DV SCORES												
	Patch	Ripple	Ravel	Flush	Distortion	Edge Cr	Allg Cr	Pothole	Block Cr	L&T Cr	Rutting	IRI
Collector	10.0	10.0	10.0	10.0	9.8	10.0	9.2	8.9	10.0	8.3	10.0	3.61
Local	9.8	10.0	6.6	10.0	8.8	10.0	6.2	5.7	7.6	6.0	10.0	6.13
Network	9.8	10.0	7.3	10.0	9.0	10.0	6.8	6.4	8.1	6.5	10.0	5.40

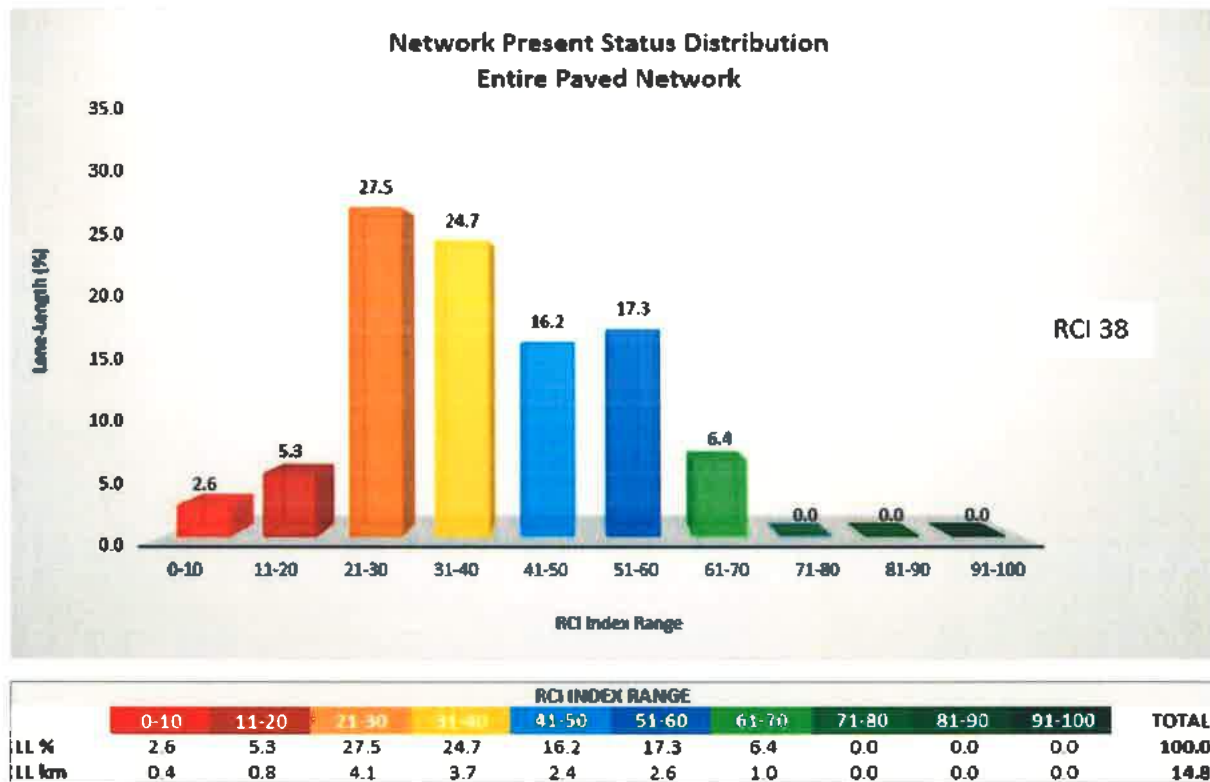
Figure 3.4: RCI Distribution for Entire Paved Network

A chart showing the distribution of RCI values, weighted by lane-kilometres, is shown in **Figure 3.4**. The plot indicates a mean RCI of 38 for the Entire Paved Network.

The results indicate a large portion of the roadway network is exhibiting signs of marginal to poor ride quality. Much of this is due to the significant presence of potholes, alligator cracking, and environmental cracking on the pavements. **Table 3.11** shows the distribution of the network between poor, marginal, and acceptable RCI values.

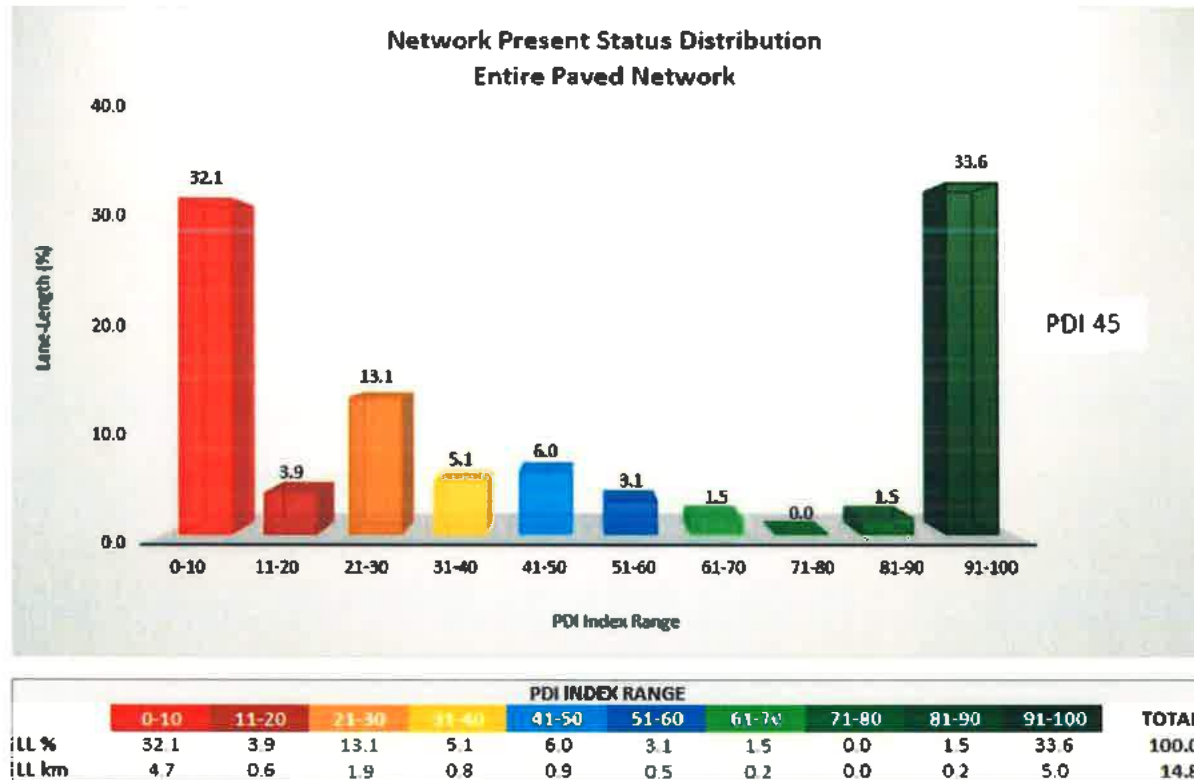
Figure 3.5: PDI Distribution for Entire Paved Network

A chart showing the distribution of PDI values, weighted by lane-kilometres, is shown in **Figure 3.5**. The plot indicates a mean PDI of 45 for the Entire Paved Network.

The results show two-thirds of the network is showing marginal to poor performance with respect to the pavement distress. Much of this is driven by the notable presence of environmental-related distresses (L&T cracking and raveling) and potholes in the roadway network, with some areas also showing fatigue-associated deterioration (alligator cracking). **Table 3.12** shows the distribution of the network between poor, marginal, and acceptable PDI values.

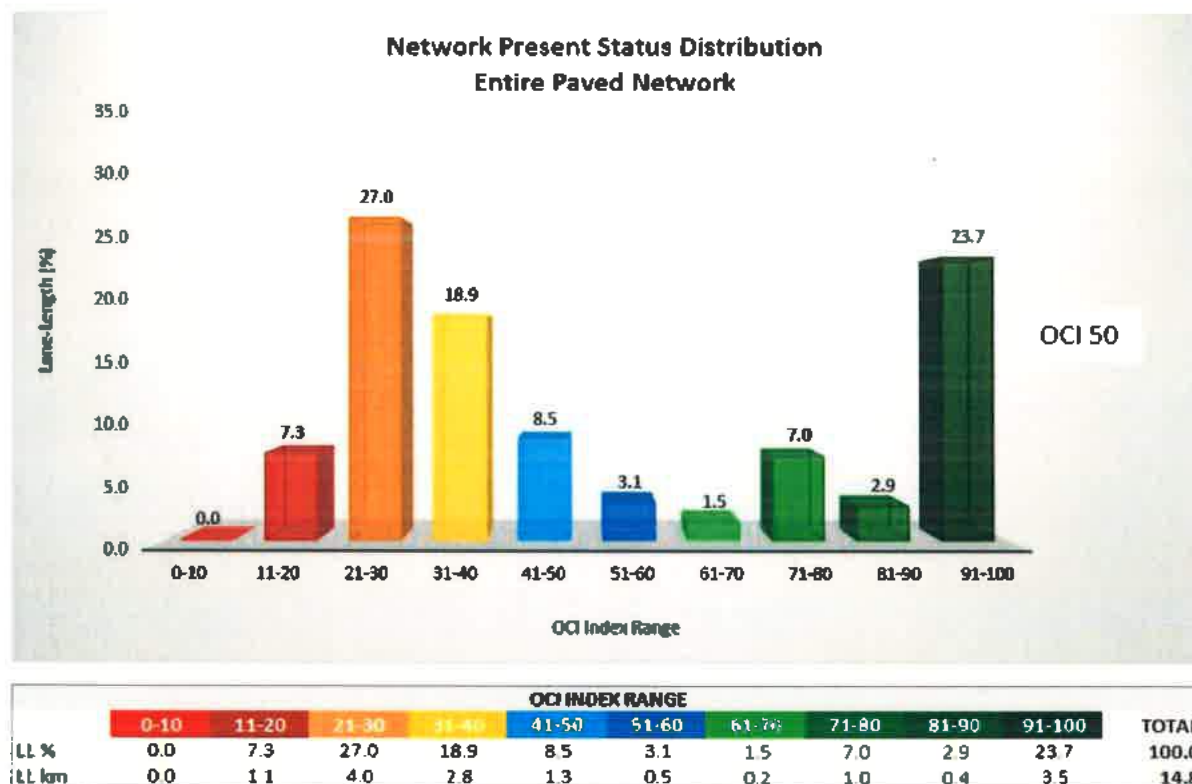
Figure 3.6: OCI Distribution for Entire Paved Network

A chart showing the distribution of OCI values, weighted by lane-kilometres, is shown in **Figure 3.6**. The plot indicates a mean OCI of 50 for the Entire Paved Network.

These results indicate two-thirds of the Entire Paved Network is in need of some form of rehabilitation with OCI values less than or equal to the trigger levels. The roughness component of the network is showing deterioration, particularly in the Local network. The Local network is also exhibiting significant distress deterioration as indicated by the PDI score of 25, which is bringing down the network average. **Table 3.13** shows the distribution of the network between in-need and acceptable OCI values.

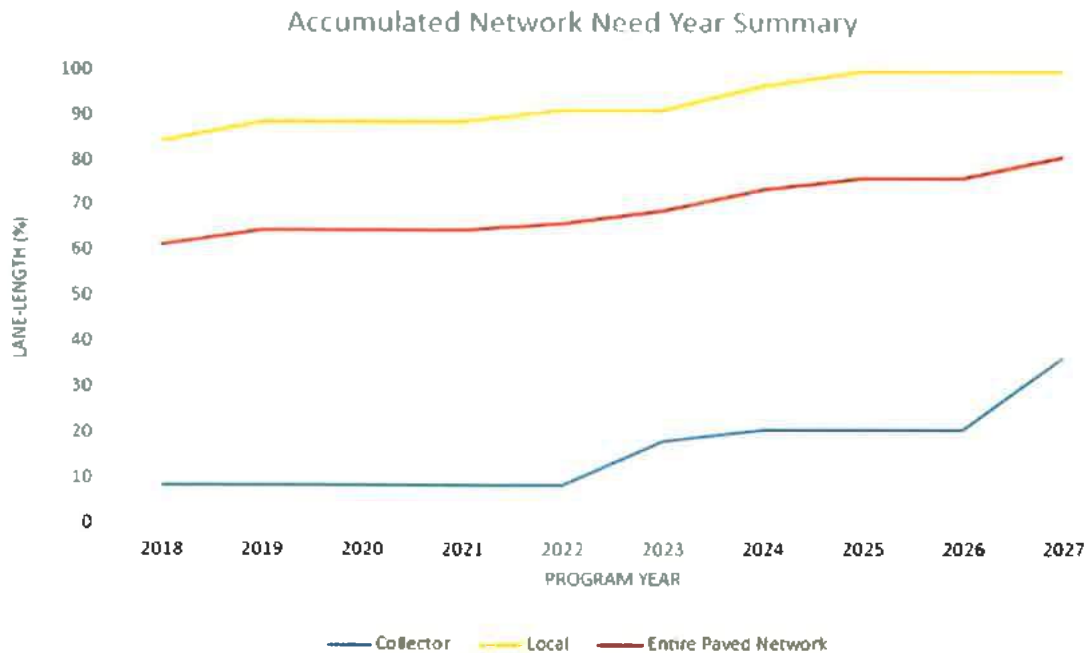
Figure 3.7: Accumulated Needs Summary (2018–2027)

The summary of the accumulating ten-year program Needs (non-funded scenario) is reported in lane-kilometres for each functional class and the entire network and shown in **Figure 3.7**.

The combined effect of the predicted rehabilitation Needs in each functional class is showing the network as a whole is predicted to have a steady increase in the number of sections that will be at or below the OCI trigger levels, resulting in a significant portion of the entire network being in Need by the end of the programming period (2027) under a non-funded scenario.

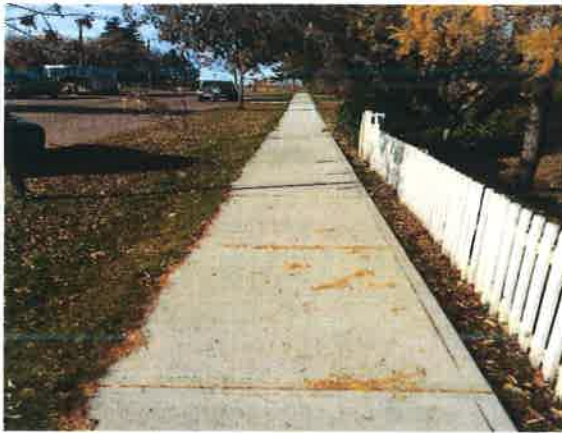
Good Sidewalk: Segment/Asset_Id 379492N
